**Flood Control Project Maintenance
Levee Inspections**

Maintenance Issue Types Only, Levee Inspection Report By Mile - Fall 2016

Reclamation District No. 2089 Stark

Waterway	Bank	Unit Miles	Inspection Start/End	Inspector
Unit No. 01 Old River	Right	1.51	10/13/2016 10/13/2016	Maksim Khashchuk

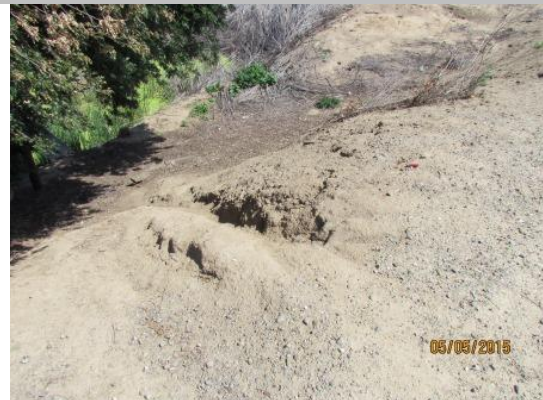
Photo 1 of 1 : FA_2016_RD2089_316_1_20160914_00001.jpg

LM Start	0.04	Rating **	M	Issue No.	1
LM End	0.04	Issue Type +	Ma	Location *	LS
Category	Earthen Levee		GPS Latitude/Longitude		
			Start	End	
Item	Encroachments		37.811474°	37.811474°	
			-121.385573°	-121.385573°	
DWR ID	DWR_RD2089_01_s_2012_1				
Comment Code					
ST : Stairway					
Inspector Comment					
Steps have been cut into the levee slope, this could become an erosion point, please fill and compact.

View of the stairs eroding into the landside levee slope.

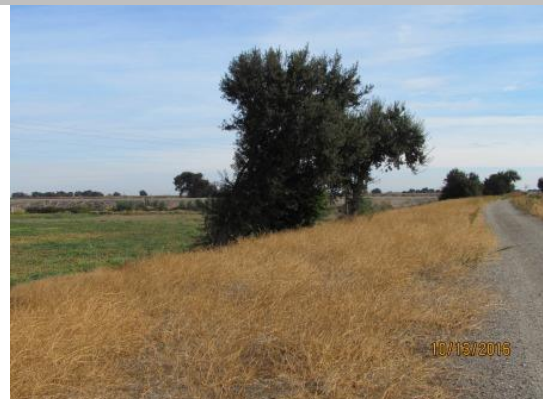
Photo 1 of 1 : FA_2016_RD2089_316_30_20161017_00045.jpg

LM Start	0.04	Rating **	M	Issue No.	30
LM End	0.24	Issue Type +	Ma	Location *	LS
Category	Earthen Levee		GPS Latitude/Longitude		
			Start	End	
Item	Vegetation		37.811474°	37.810451°	
			-121.385573°	-121.389109°	
DWR ID	DWR_RD2089_01_f_2016_30				
Comment Code					
V1 : Control annual grass and weeds on the levee slopes and easements.					
Inspector Comment

View of the vegetation on the landside levee slope.

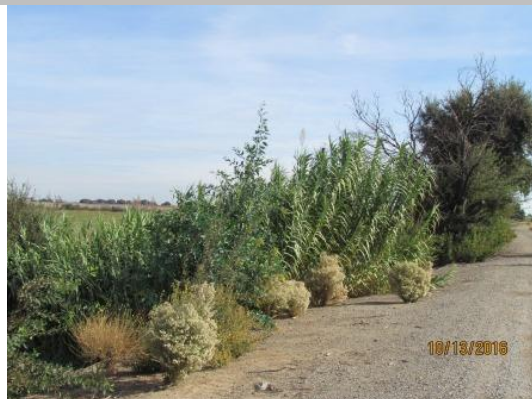
Photo 1 of 2 : FA_2016_RD2089_316_19_20161017_00051.jpg

LM Start	0.33	Rating **	U	Issue No.	19
LM End	0.33	Issue Type +	Ma	Location *	LS
Category	Earthen Levee			GPS Latitude/Longitude	
				Start	End
Item	Vegetation			37.810002 °	37.810002 °
				-121.390674 °	-121.390674 °
DWR ID	DWR_RD2089_01_s_2012_19				
Comment Code					
V2 : Remove the wild growth other than native grasses from the levee slopes.					
Inspector Comment					
Arundo is thick and blocks visibility and access.

View of the arundo back on the landside levee slope. Fall 2016

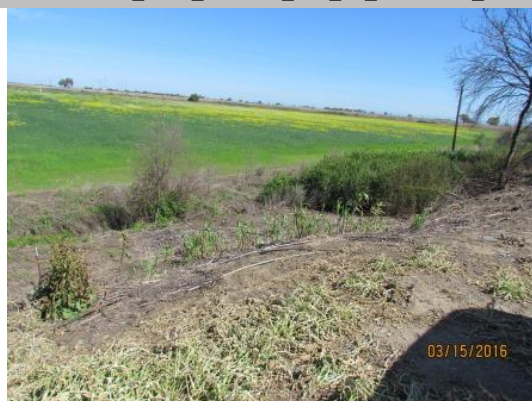
Photo 2 of 2 : FA_2016_RD2089_316_19_20160914_00015.jpg

Arundo was trimmed back from the road and needs to be maintained so that it does not obstruct visibility and access to the landside toe.

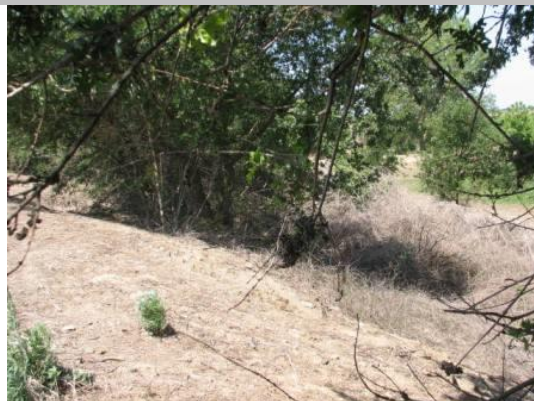
Photo 1 of 1 : FA_2016_RD2089_316_28_20160914_00018.jpg

LM Start	0.41	Rating **	M	Issue No.	28
LM End	0.46	Issue Type +	Ma	Location *	LS
Category	Earthen Levee			GPS Latitude/Longitude	
				Start	End
Item	Vegetation			37.809593 °	37.809507 °
				-121.391963 °	-121.392907 °
DWR ID	DWR_RD2089_01_s_2012_28				
Comment Code					
V2 : Remove the wild growth other than native grasses from the levee slopes.					
Inspector Comment					
Vegetation is too thick to allow access and visibility. Some thick patches of shrubs remain and continue to block visibility and access.

05/24/2011 Photo shows thick dead vegetation and continuation of trees in area that are preventing access and visibility of landside slope and toe.

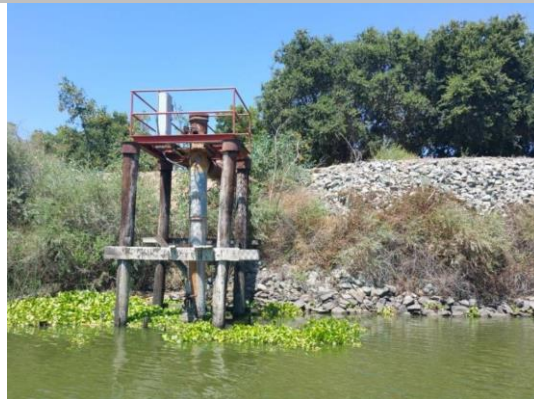
Photo 1 of 2 : SJR2016_RD2089U01RM29.8_1.jpg

LM Start	0.46	Rating **	M	Issue No.	5
LM End	0.46	Issue Type +	Ma	Location *	WS
Category	Supplemental			GPS Latitude/Longitude	
				Start	End
Item	DWR Erosion Survey			37.809394 °	37.809394 °
				-121.392791 °	-121.392791 °
DWR ID					
Comment Code					
Inspector Comment					
07/25/2016: No significant change observed.					
06/25/2015: No significant change observed.					
07/02/2014: No significant change observed.					
08/13/2013: No significant change observed.					
08/07/2012: The site has been visited by boat survey. No significant change observed					
08/23/2011: The site shows loose material around the pipe crossing.					
The operation of the pipe might have caused an impact on the levee.					
[2016 Site ID:RD2089U01RM29.8]

Front view of the site. Note the irrigation pipe on the site.

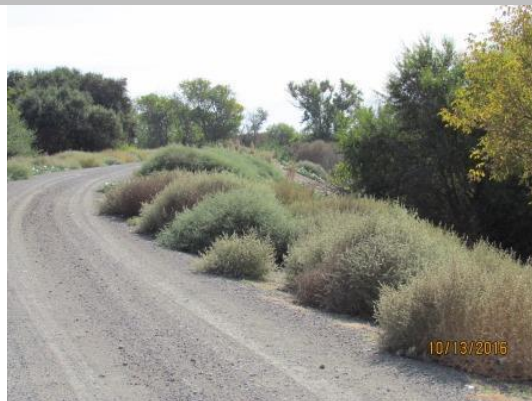
Photo 1 of 1 : FA_2016_RD2089_316_29_20161017_00050.jpg

LM Start	0.50	Rating **	U	Issue No.	29
LM End	0.55	Issue Type +	Ma	Location *	WS
Category	Earthen Levee			GPS Latitude/Longitude	
				Start	End
Item	Vegetation			37.809814 °	37.810132 °
				-121.393481 °	-121.394234 °
DWR ID	DWR_RD2089_01_f_2016_29				
Comment Code					
V2 : Remove the wild growth other than native grasses from the levee slopes.					
Inspector Comment					
Tumbleweeds are on the levee slope.

View of the vegetation on the waterside levee slope.

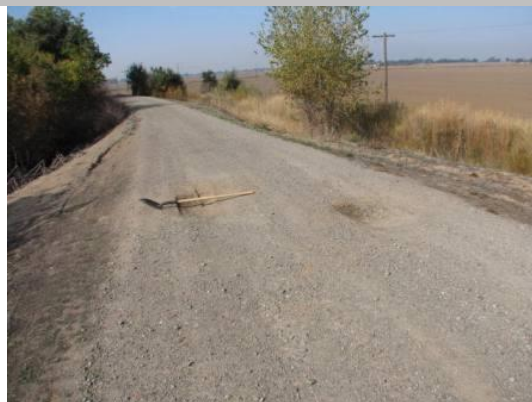
Photo 1 of 1 : FA_2016_RD2089_316_14_20160914_00012.jpg

LM Start	0.54	Rating **	M	Issue No.	14
LM End	0.54	Issue Type +	Ma	Location *	CR
Category	Earthen Levee			GPS Latitude/Longitude	
				Start	End
Item	Crown Surface / Depressions / Rutting			37.810087 °	37.810087 °
				-121.394200 °	-121.394200 °
DWR ID	DWR_RD2089_01_s_2012_14				
Comment Code					
C3 : Add appropriate gravel or road base. Grade and compact.					
Inspector Comment					
11/10/2011 Minor depressions will cause ponding.

11/10/2011 Depressions in crown.

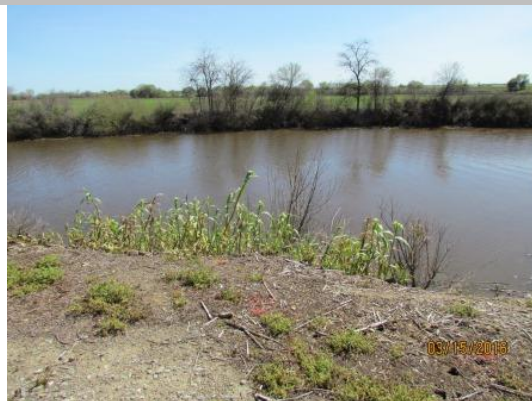
Photo 1 of 1 : FA_2016_RD2089_316_33_20160914_00019.jpg

LM Start	0.94	Rating **	A/W	Issue No.	33
LM End	0.94	Issue Type +	Ma	Location *	WS
Category	Earthen Levee			GPS Latitude/Longitude	
				Start	End
Item	Vegetation			37.806397°	37.806397°
				-121.397758°	-121.397758°
DWR ID	DWR_RD2089_01_s_2012_33				
Comment Code					
V2 : Remove the wild growth other than native grasses from the levee slopes.					
Inspector Comment					
Arundo on waterside impedes visibility and access to waterside slope.

Arundo was trimmed back and needs to be maintained to allow visibility and access.

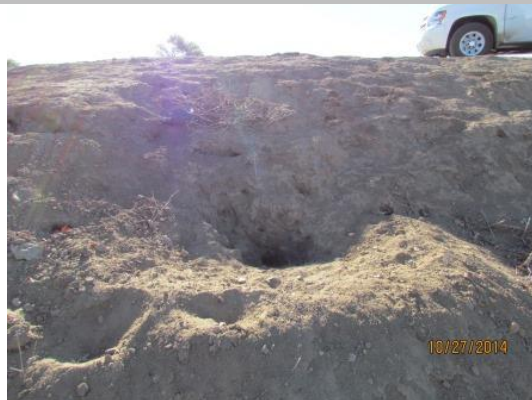
Photo 1 of 1 : FA_2016_RD2089_316_16_20160914_00013.jpg

LM Start	1.12	Rating **	M	Issue No.	16
LM End	1.12	Issue Type +	Ma	Location *	LS
Category	Earthen Levee			GPS Latitude/Longitude	
				Start	End
Item	Animal Control			37.805699 °	37.805699 °
				-121.400952 °	-121.400952 °
DWR ID	DWR_RD2089_01_f_2014_16				
Comment Code					
A3 : No rodents visible, but rodent burrows visible; need to backfill and compact or grout burrows.					
Inspector Comment					
Some rodent holes have collapsed. Backfill the remaining voids in the levee slope.

View of the rodent burrow on the landside levee slope.

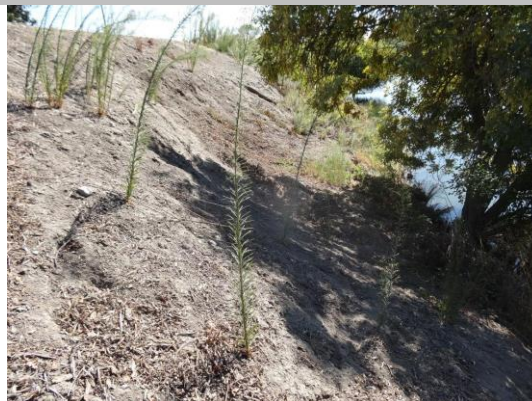
Photo 1 of 2 : SJR2016_RD2089U01RM29.04_1.jpg

09/16/2016: The river was not navigable near the site due to the dense water grass, so the site was visited by land survey. No significant change observed.
 06/25/2015: No significant change observed.
 07/02/2014: No significant change observed.
 08/13/2013: The erosion is around a tree at the levee toe. Dense vegetation is visible. [2016 Site ID:RD2089U01RM29.04]

View of the erosion from levee slope.

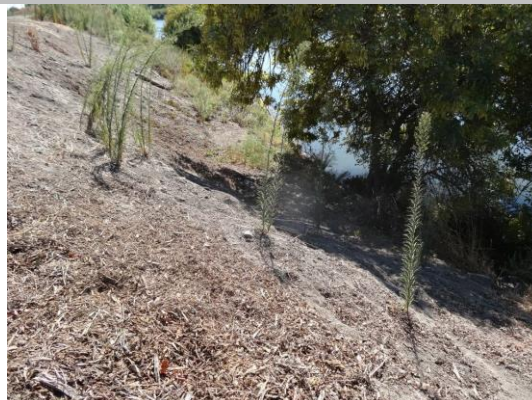
Photo 2 of 2 : SJR2016_RD2089U01RM29.04_4.jpg

Close view of the erosion.

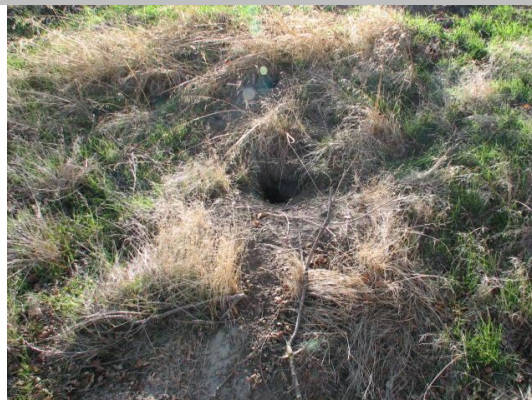
Photo 1 of 1 : FA_2016_RD2089_316_47_20160914_00025.jpg

LM Start	1.40	Rating **	M	Issue No.	47
LM End	1.40	Issue Type +	Ma	Location *	LS
Category	Earthen Levee			GPS Latitude/Longitude	
				Start	End
Item	Animal Control			37.806268 °	37.806268 °
				-121.405874 °	-121.405874 °
DWR ID	DWR_RD2089_01_s_2012_47				
Comment Code					
A3 : No rodents visible, but rodent burrows visible; need to backfill and compact or grout burrows.					
Inspector Comment					
11/10/2011 No rodents visible, but active burrows are present.

11/10/2011 Active rodent burrow on landside slope.

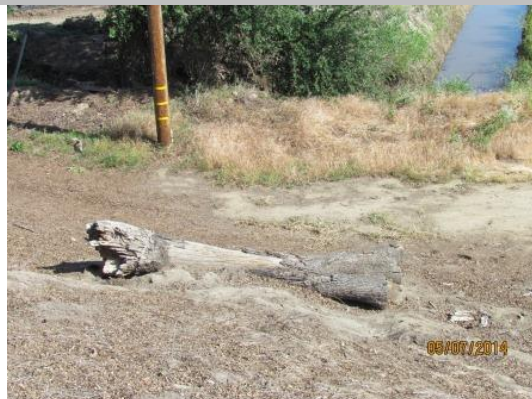
Photo 1 of 1 : FA_2016_RD2089_316_46_20160914_00024.jpg

LM Start	1.40	Rating **	M	Issue No.	46
LM End	1.40	Issue Type +	Ma	Location *	LS
Category	Earthen Levee			GPS Latitude/Longitude	
				Start	End
Item	Encroachments			37.806266 °	37.806266 °
				-121.405876 °	-121.405876 °
DWR ID	DWR_RD2089_01_s_2012_46				
Comment Code					
TR : Tree or limb					
Inspector Comment					
11/10/2011 Downed tree at levee toe prevents access to levee from landside.

Decaying tree at the landside levee toe is obstructing visibility and access.

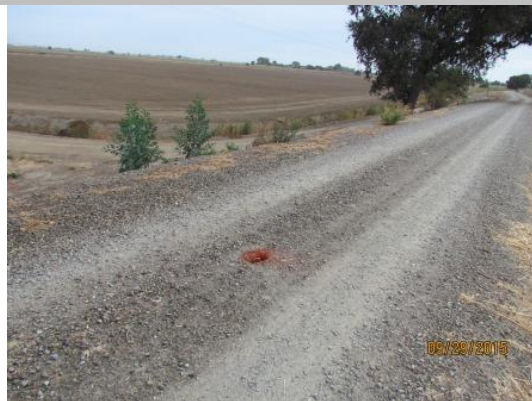
Photo 1 of 1 : FA_2016_RD2089_316_26_20160914_00017.jpg

View of the rodent hole on the levee crown.

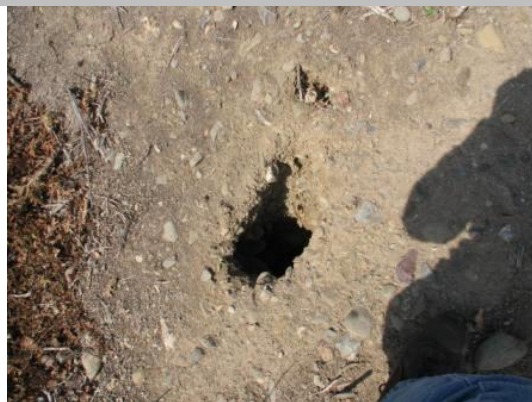
Photo 1 of 1 : FA_2016_RD2089_316_49_20160914_00026.jpg

LM Start	1.44	Rating **	M	Issue No.	49
LM End	1.44	Issue Type +	Ma	Location *	WS
Category	Earthen Levee			GPS Latitude/Longitude	
				Start	End
Item	Animal Control			37.806383 °	37.806383 °
				-121.406599 °	-121.406599 °
DWR ID	DWR_RD2089_01_s_2012_49				
Comment Code					
A3 : No rodents visible, but rodent burrows visible; need to backfill and compact or grout burrows.					
Inspector Comment					
Deep burrow on waterside needs to be filled.

11/10/2011 Deep burrow on waterside.

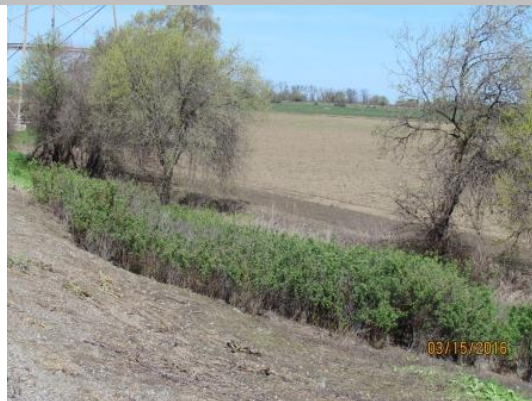
Photo 1 of 1 : FA_2016_RD2089_317_20_20160914_00016.jpg

View of the vegetation on the landside levee slope.

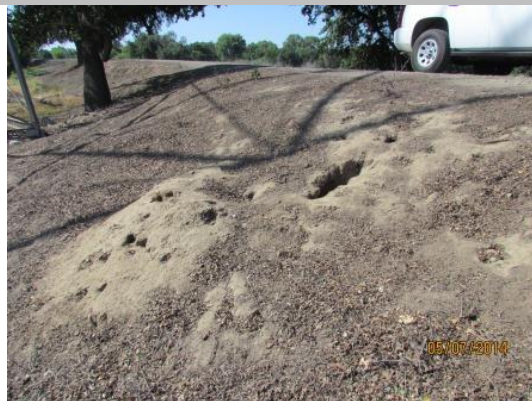
Photo 1 of 1 : FA_2016_RD2089_317_48_20160914_00032.jpg

View of the rodent burrow on the landside levee slope.

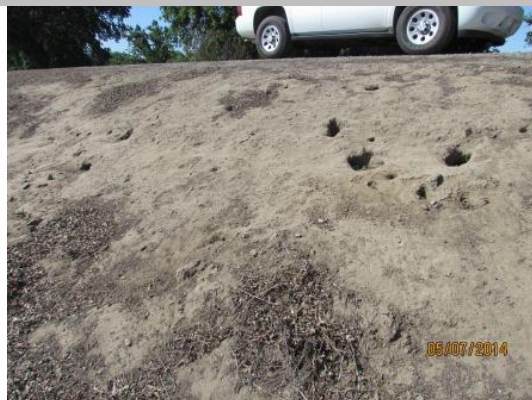
Photo 1 of 1 : FA_2016_RD2089_317_49_20160914_00033.jpg

LM Start	0.21	Rating **	M	Issue No.	49
LM End	0.21	Issue Type +	Ma	Location *	LS
Category	Earthen Levee			GPS Latitude/Longitude	
				Start	End
Item	Animal Control			37.809148 °	37.809148 °
				-121.409897 °	-121.409897 °
DWR ID	DWR_RD2089_02_f_2013_49				
Comment Code					
A3 : No rodents visible, but rodent burrows visible; need to backfill and compact or grout burrows.					
Inspector Comment

View of the multiple rodent burrows on the landside levee hinge and slope.

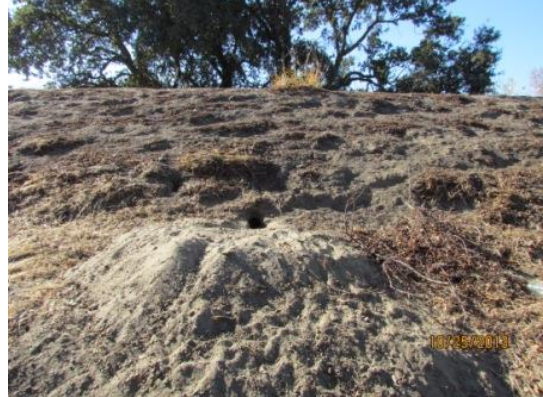
Photo 2 of 3 : FA_2016_RD2089_317_53_20160914_00037.jpg

View of the rodent burrow on the landside levee slope.

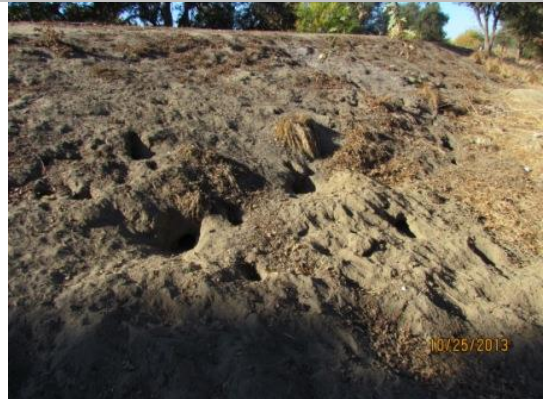
Photo 3 of 3 : FA_2016_RD2089_317_53_20160914_00038.jpg

Another view of the multiple rodent burrows on the landside levee slope.

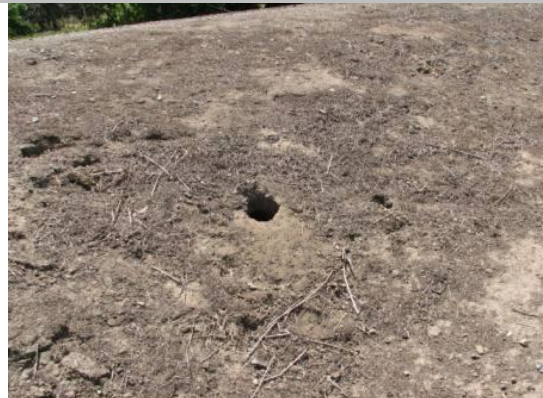
Photo 1 of 1 : FA_2016_RD2089_317_26_20160914_00019.jpg

05/24/2011 Active rodent burrow.

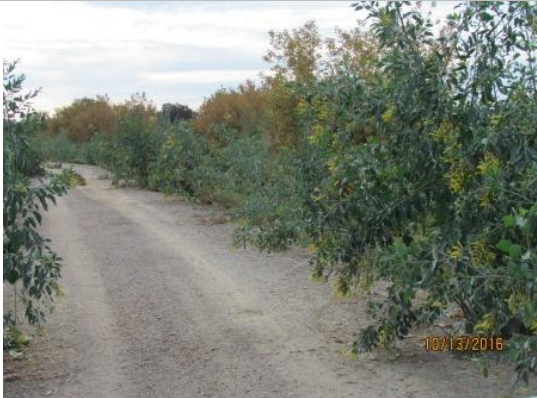
Photo 1 of 1 : FA_2016_RD2089_317_44_20161017_00056.jpg

View of the vegetation on the levee slopes.

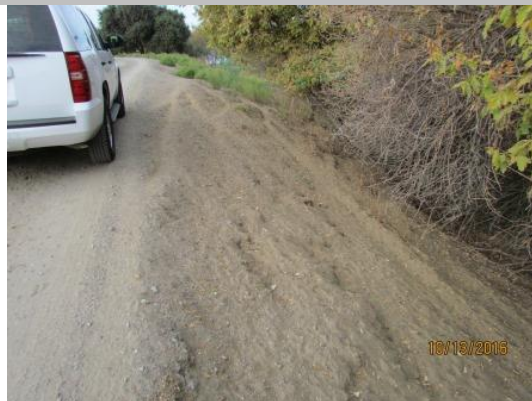
Photo 1 of 1 : FA_2016_RD2089_317_43_20161017_00055.jpg

LM Start	0.66	Rating **	M	Issue No.	43
LM End	0.66	Issue Type +	Ma	Location *	WS
Category	Earthen Levee			GPS Latitude/Longitude	
				Start	End
Item	Animal Control			37.812677 °	37.812677 °
				-121.415393 °	-121.415393 °
DWR ID	DWR_RD2089_02_f_2016_43				
Comment Code					
A2 : Repair the levee slope damaged by livestock and prevent large animal access.					
Inspector Comment

View of the animal paths on the waterside levee slope.

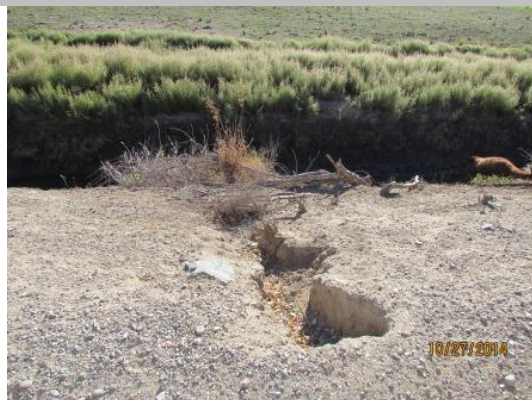
Photo 1 of 1 : FA_2016_RD2089_317_15_20160914_00014.jpg

LM Start	0.76	Rating **	M	Issue No.	15
LM End	0.76	Issue Type +	Ma	Location *	LS
Category	Earthen Levee			GPS Latitude/Longitude	
				Start	End
Item	Erosion / Bank Caving			37.813934 °	37.813934 °
				-121.414320 °	-121.414320 °
DWR ID	DWR_RD2089_02_f_2014_15				
Comment Code					
E2 : Schedule repair of erosion site prior to the next inspection.					
Inspector Comment

View of the scour from surface runoff on the landside levee slope.

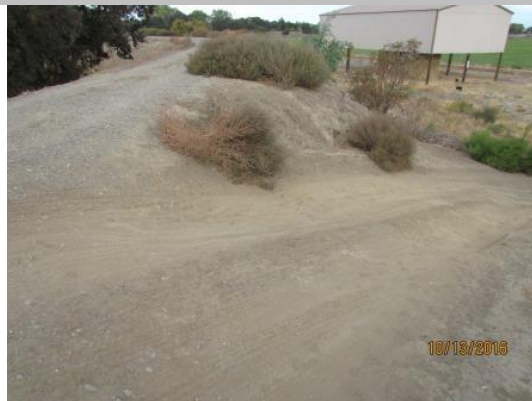
Photo 1 of 1 : FA_2016_RD2089_317_42_20161017_00052.jpg

LM Start	0.84	Rating **	M	Issue No.	42
LM End	0.84	Issue Type +	Ma	Location *	LS
Category	Earthen Levee			GPS Latitude/Longitude	
				Start	End
Item	Slope Stability			37.814931 °	37.814931 °
				-121.414756 °	-121.414756 °
DWR ID	DWR_RD2089_02_f_2016_42				
Comment Code					
S3 : Repair the levee slope damaged by vehicle traffic and prevent access where possible.					
Inspector Comment					
Ramp is encroaching into the levee slope. Add appropriate material to stabilize the slope.

View of the ramp on the landside levee slope.

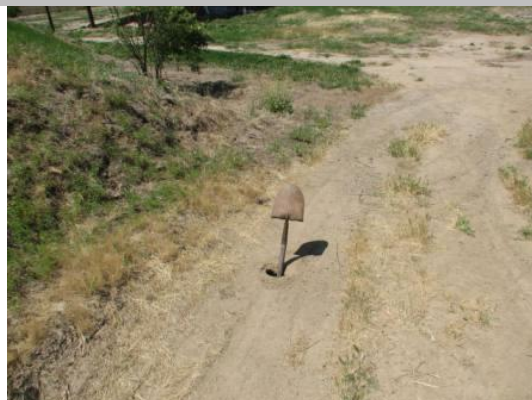
Photo 1 of 3 : FA_2016_RD2089_317_40_20160914_00028.jpg

LM Start	0.85	Rating **	U	Issue No.	40
LM End	0.90	Issue Type +	Ma	Location *	LS
Category	Earthen Levee			GPS Latitude/Longitude	
				Start	End
Item	Animal Control			37.814997 °	37.814970 °
				-121.414774 °	-121.415767 °
DWR ID	DWR_RD2089_02_s_2012_40				
Comment Code					
A1 : Exterminate rodents and backfill and compact or grout burrows.					
Inspector Comment					
Numerous burrows on landside slope adjacent to hay storage area. Deep burrows in crown and landside ramp.

05/24/2011 Deep vertical burrow in ramp on land side of levee.

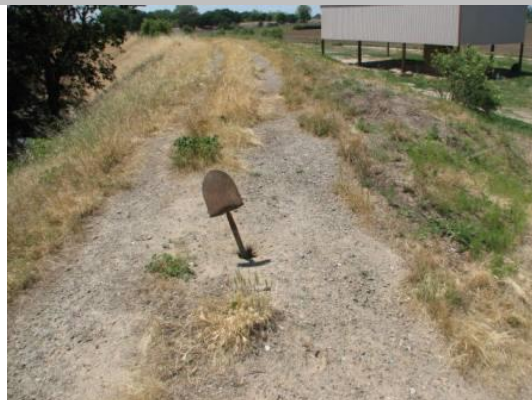
Photo 2 of 3 : FA_2016_RD2089_317_40_20160914_00029.jpg

05/24/2011 Deep vertical burrow in levee crown.

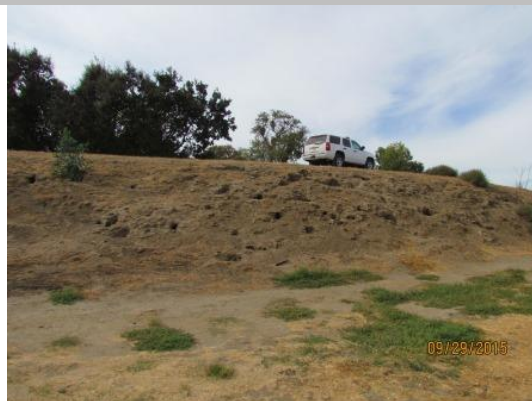
Photo 3 of 3 : FA_2016_RD2089_317_40_20160914_00030.jpg

View of the multiple rodent holes on the landside levee slope.

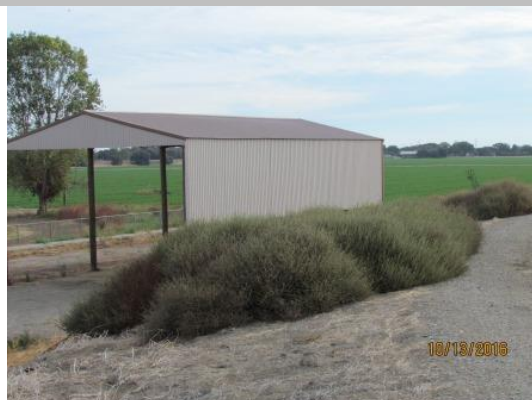
Photo 1 of 1 : FA_2016_RD2089_317_39_20161017_00053.jpg

LM Start	0.85	Rating **	U	Issue No.	39
LM End	0.88	Issue Type +	Ma	Location *	LS
Category	Earthen Levee			GPS Latitude/Longitude	
				Start	End
Item	Vegetation			37.814967 °	37.815017 °
				-121.414839 °	-121.415455 °
DWR ID	DWR_RD2089_02_f_2016_39				
Comment Code					
V2 : Remove the wild growth other than native grasses from the levee slopes.					
Inspector Comment					
Tumbleweeds on landside levee hinge and slope.

View of the vegetation on the landside levee slope.

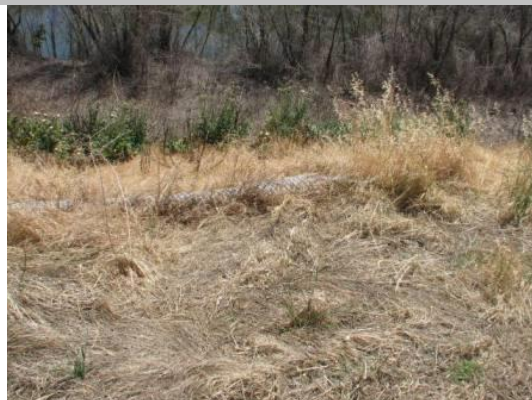
Photo 1 of 1 : FA_2016_RD2089_317_41_20160914_00031.jpg

05/24/2011 Old CMP left on waterside levee slope, needs to be removed.

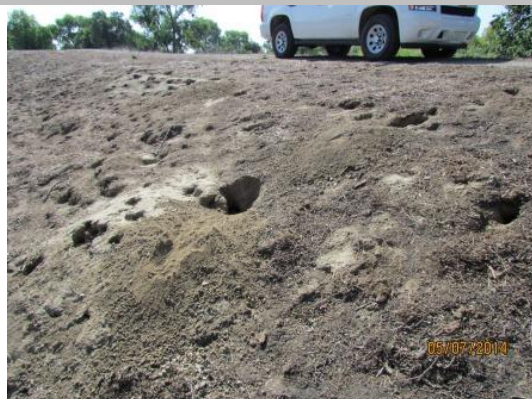
Photo 1 of 1 : FA_2016_RD2089_317_5_20160914_00004.jpg

LM Start	0.95	Rating **	U	Issue No.	5
LM End	0.95	Issue Type +	Ma	Location *	LS
Category	Earthen Levee			GPS Latitude/Longitude	
				Start	End
Item	Animal Control			37.814915 °	37.814915 °
				-121.416606 °	-121.416606 °
DWR ID	DWR_RD2089_02_s_2014_5				
Comment Code					
A1 : Exterminate rodents and backfill and compact or grout burrows.					
Inspector Comment

View of the rodent holes on the landside levee slope.

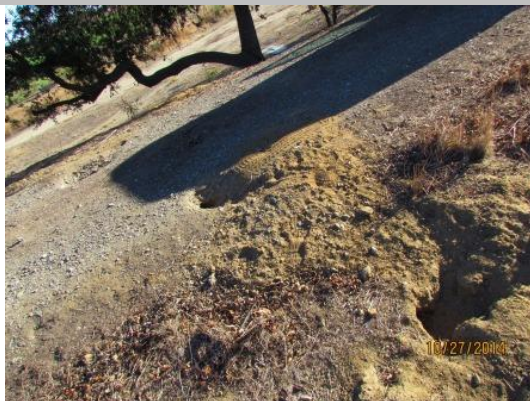
Photo 1 of 2 : FA_2016_RD2089_317_12_20160914_00010.jpg

View of several large rodent holes on the levee crown.

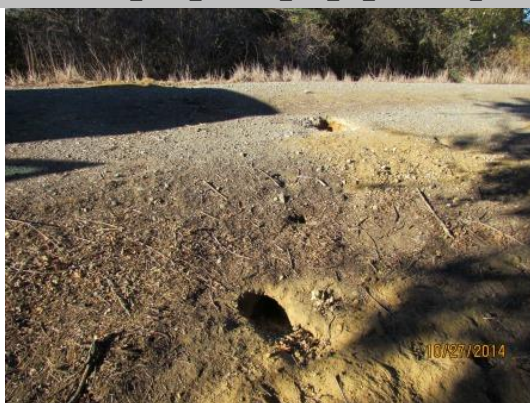
Photo 2 of 2 : FA_2016_RD2089_317_12_20160914_00011.jpg

View of several rodent burrows on landside levee hinge and crown.

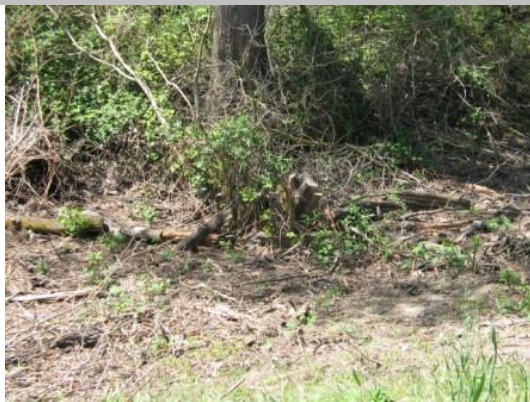
Photo 1 of 1 : FA_2016_RD2089_317_29_20160914_00021.jpg

LM Start	1.05	Rating **	N	Issue No.	29
LM End	1.05	Issue Type +	Ma	Location *	WS
Category	Earthen Levee			GPS Latitude/Longitude	
				Start	End
Item	Trim / Thin Trees			37.815629 °	37.815629 °
				-121.418133 °	-121.418133 °
DWR ID	DWR_RD2089_02_s_2012_29				
Comment Code					
T5 : Tree stumps.					
Inspector Comment					
14" dia stump. Could not verify as the area is overgrown with high weeds.

Tree stump >2" left after vegetation and tree removal.

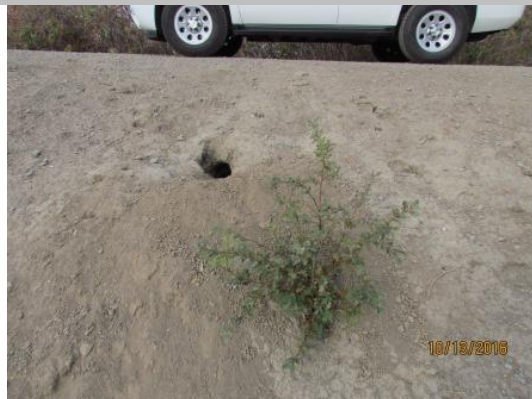
Photo 1 of 1 : FA_2016_RD2089_317_28_20161017_00049.jpg

View of the rodent burrow in the landside levee slope.
